ANOTHER B-I-G INSPECTION

CONFIDENTIAL INSPECTION REPORT

PROPERTY LOCATION:	1313 Mockingbird Lane	S/D:	DRESDEN MANOR
CITY, STATE, ZIP:	Atlanta, GA 30345		
DATE OF INSPECTION:	December, 18, 2013 [TH]	TIME OF INSPECTION:	~9:00 AM
STYLE OF DWELLING:	Ranch on Basement	AGE OF PROPERTY:	~52 YEARS
WEATHER CONDITIONS DURING INSPECTION:	Sunny 53°F		
PEOPLE PRESENT DURING INSPECTION:	Inspector Only

INSPECTOR: MIKE SYLVESTER
INTERNATIONAL CODE COUNCIL CERTIFIED
NO. 5228859-R5

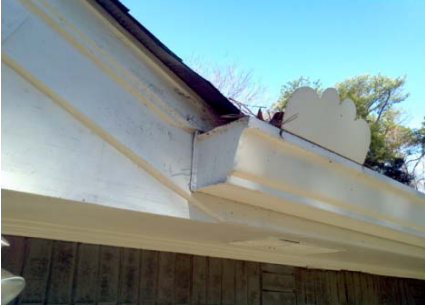
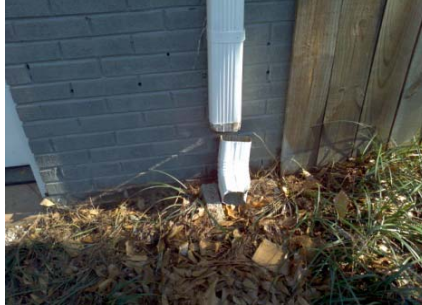
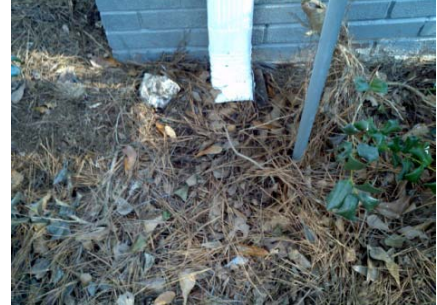
- #1** * The gutters and down spouts need to be cleared, repaired and extended to carry roof water away from the base of the foundation of the home.

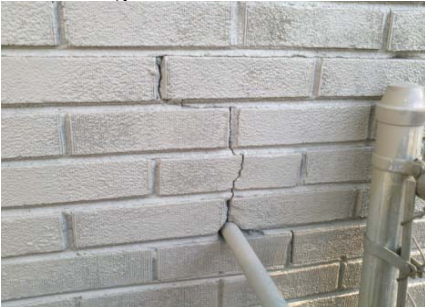
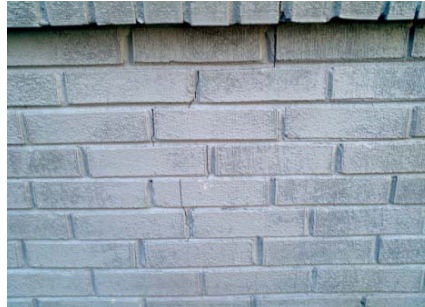
- #2** * There is visible cracking in the exterior brick walls from past settling that should have been patched and sealed prior to painting. While the cracking is not a threat to the structure moisture could seep into the cracks and cause further damage.

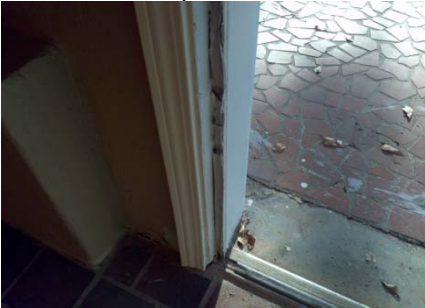
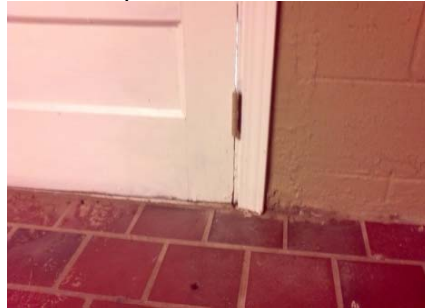
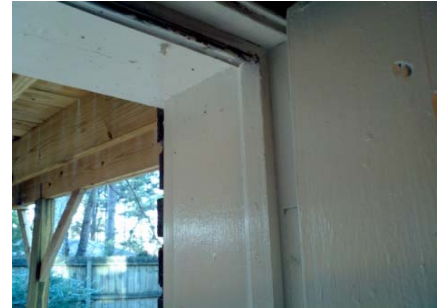
- #3** * The exterior door to the unfinished shop in the rear corner of the basement is very old and has ineffective or missing weather strips and thresholds. Repairs will be required.

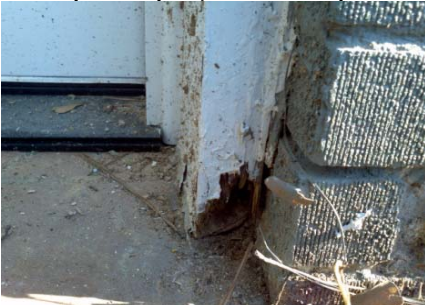
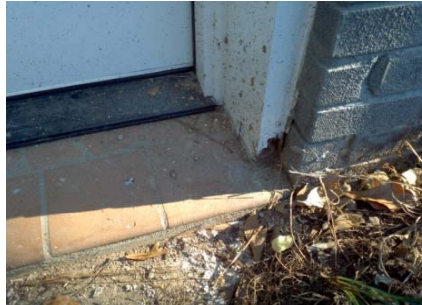
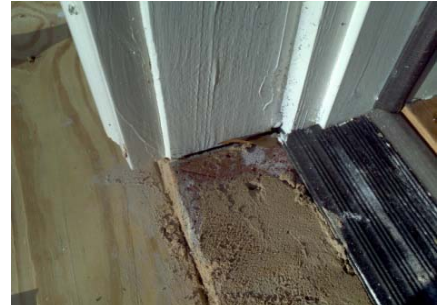
- #4** * There is water damaged and rotted wood trim at the exterior doors of the basement and to the rear deck that will require repair, caulk and paint.

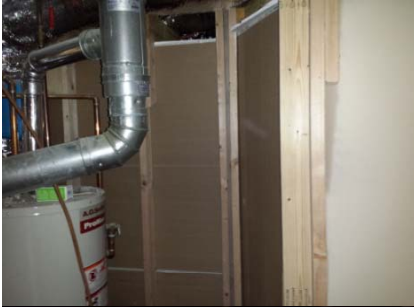
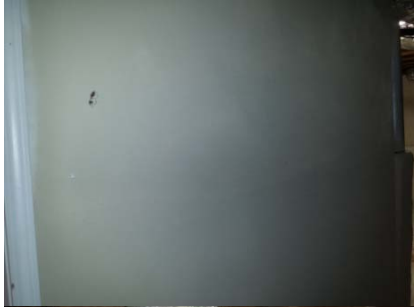
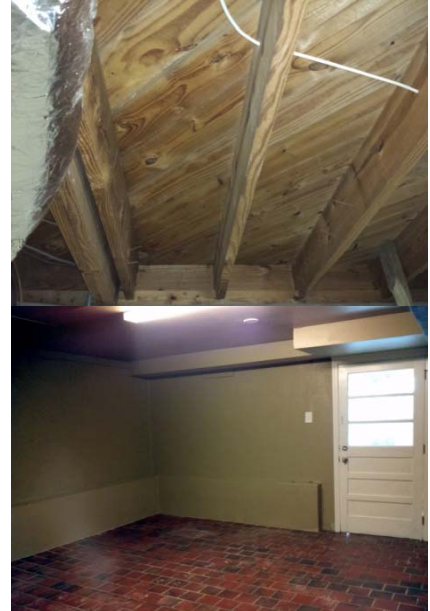
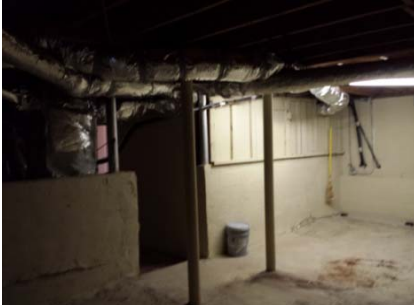
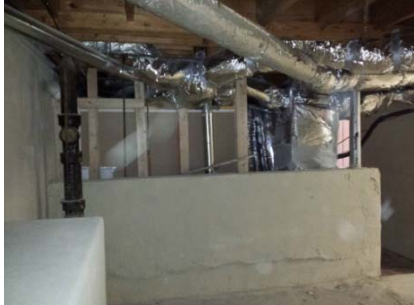
#7

* The basement of this home is said to be finished and there are two rooms with carpeting and an acceptable ceiling height, electrical outlets and windows to be considered living spaces however there is no visible insulation installed to define the living envelope. While the exterior walls could not be verified the interior frame walls and doors separating the living from non-living spaces are not insulated and in the doors have no weather stripping. Additionally the exposed ceilings in the unfinished areas need to be insulated to R-19 and the exposed frame walls in the front basement need to be insulated to R-13. The laundry area would have to be isolated from the rear unfinished shop in the rear corner as the exterior walls of this area are not finished and there are no electrical outlets in the large area further making in a non-living area.

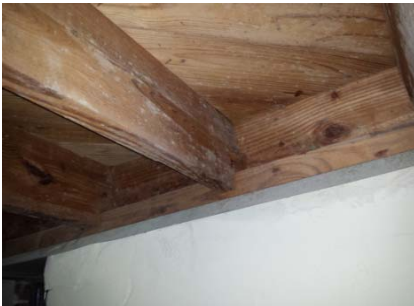
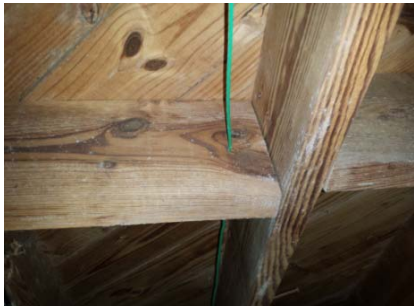
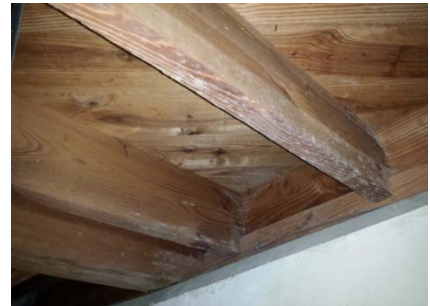
#8

* There is some light surface mold visible on the floor joists and sub flooring in the front basement area that will need to be cleaned with a bleach solution and dried out for health and welfare.

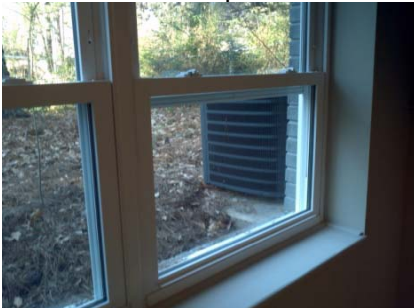
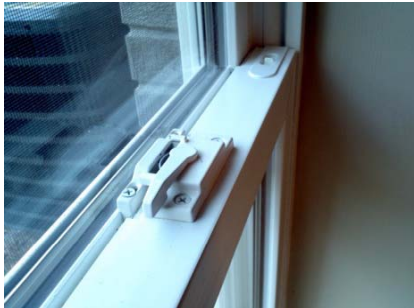
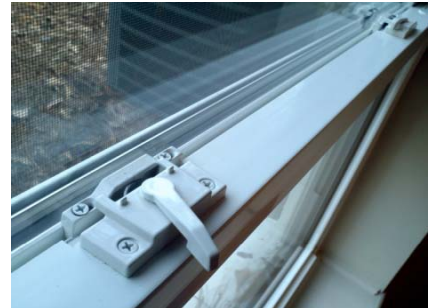
#9

* There is a window in the basement on the side exterior wall toward the front of the basement that has hardware that does not line up and latch closed.

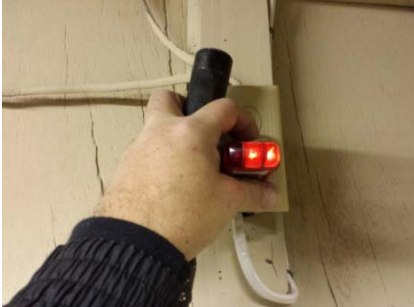
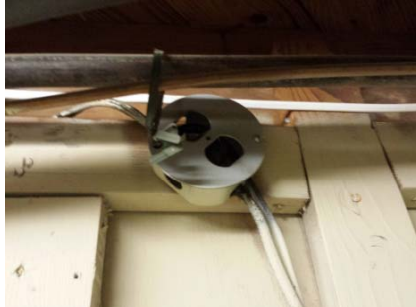
- #11 * There is an open electrical outlet box and an outlet that is not GFCI protected, although grounded< outlet in the unfinished forward basement. The box needs a blank cover plate and the outlet must be GFCI protected to meet 1991 codes.

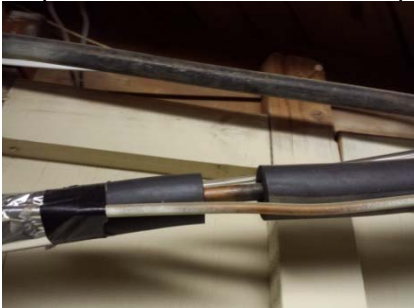
- #12 * There is an open gap in the AC coolant line visible in the front unfinished basement that will need to be sealed to prevent condensation from dripping off the line in the cooling mode.

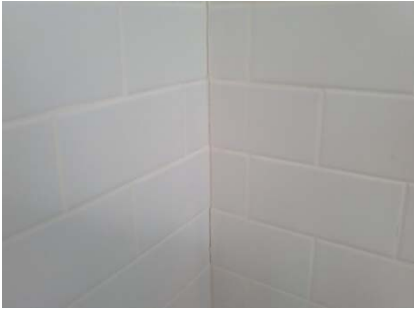
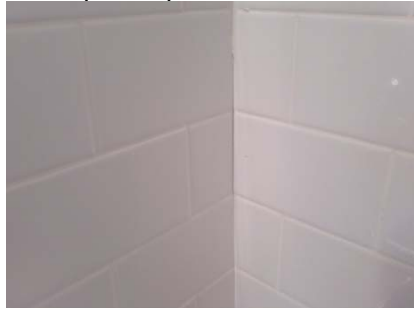
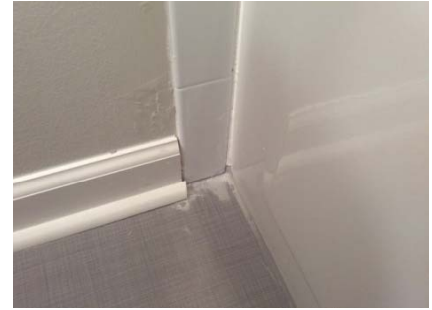
- #13 * There is deterioration in the grouting of the seams of the hall bathroom tub/shower at the corner seams and at the walls and floor outside the tub that will require repair.

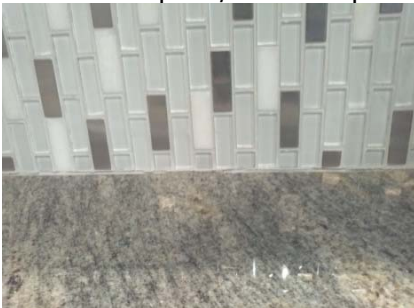
- #14 * The backsplash/counter top seam in the kitchen will need to be caulk sealed.

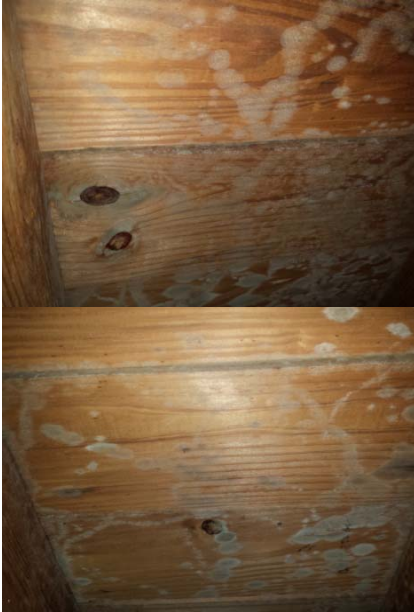
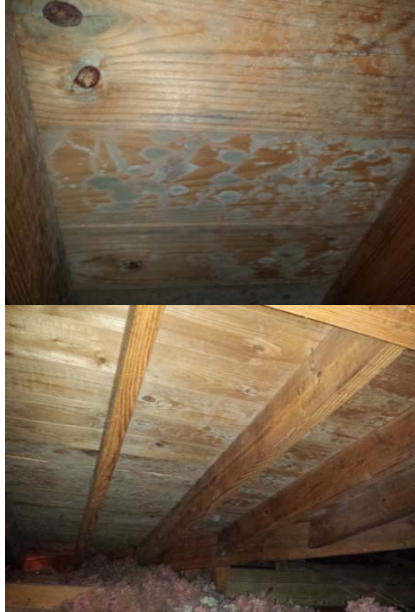
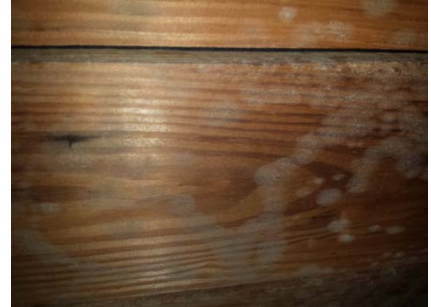
- #15** * There is a wide spread mold or fungus visible on the roof framing and sheathing, primarily forward from the front of attic access to the front gable vent. Recommend evaluation and remediation by a qualified Environmental Contractor to identify and remediate the growth.

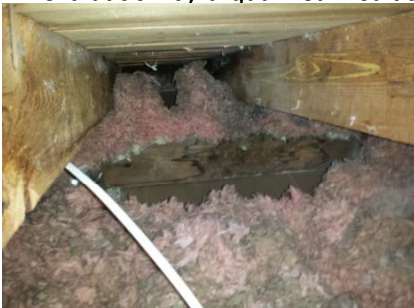
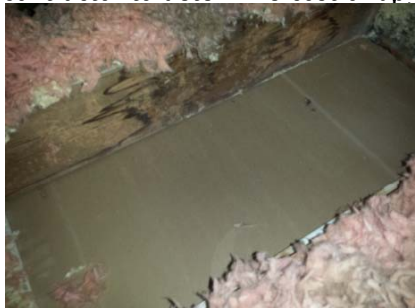
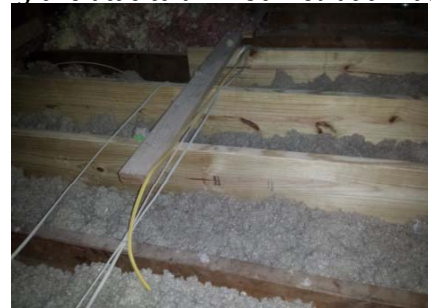
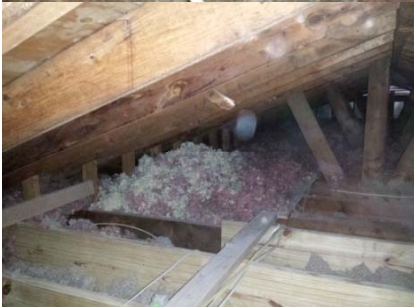
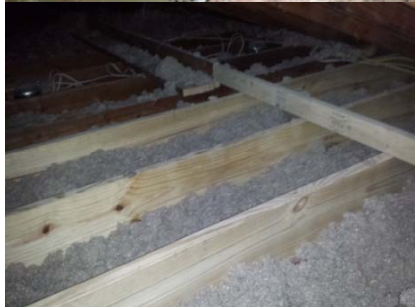
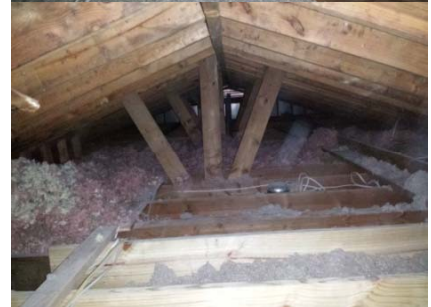
- #16** * Current code requires an insulation blanket in the attic with an R-30 rating which is approximately an average depth of 12 inches on the attic floor. The insulation in this attic, where properly spread may be an R-19 and there are areas where the insulation was moved or removed for work to be completed and was not put back in place. Recommend evaluation by a qualified insulation contractor to determine cost of upgrading this attic to an R-30 insulation rating.

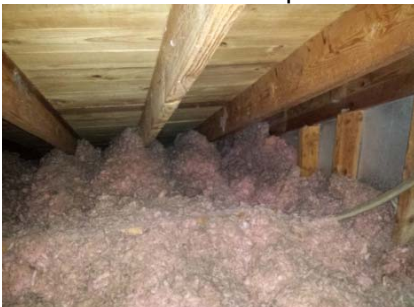
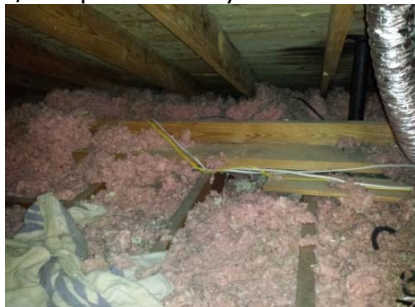
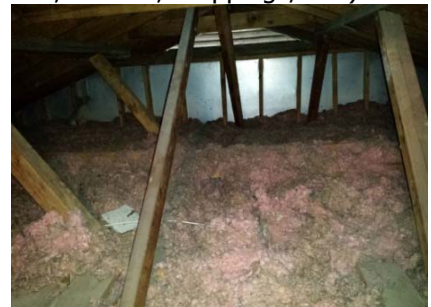
- #17** * There is evidence of past rodent and/or squirrel activity on the insulation (trails, tunnels, droppings, etc.).

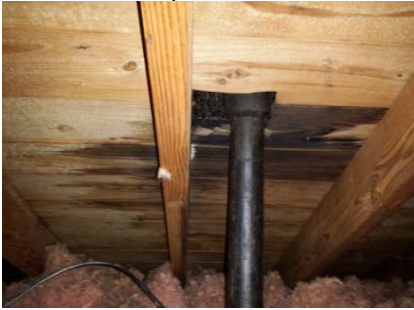
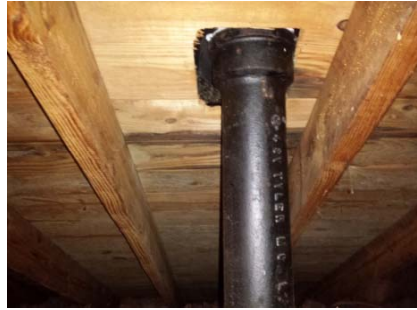
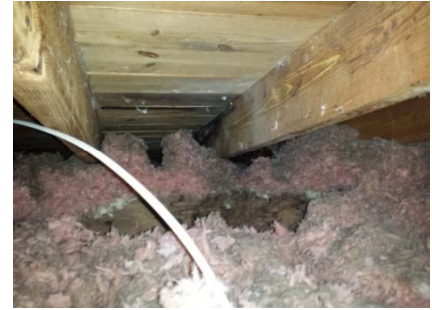
- #18** * There are water stained roof sheathing boards around the roof penetrations from past leaks that should have been repaired when the roof shingles were replaced, the areas should be monitored during heavy storms to ensure leaks are not active as there was no moisture at the time of inspection. Boards may need to be replaced when the shingles are next replaced.

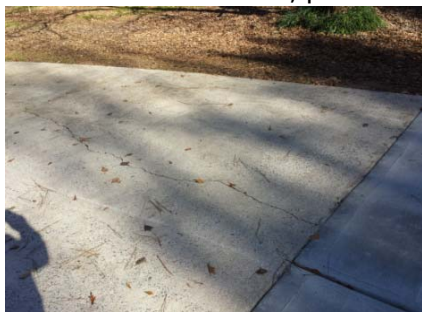
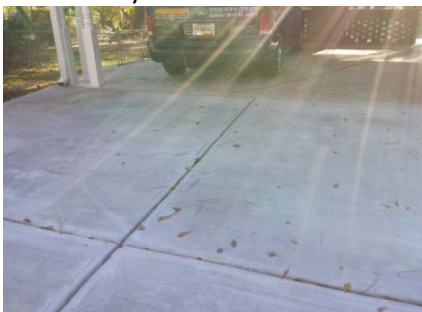
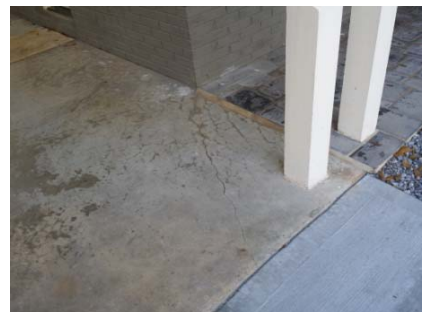
- #1** * There is visible deterioration and cracking in and on the surface of the driveway that appears to be from age, erosion and poor construction methods common to the area. The present condition does not pose a threat to the structure of the house. However, potential trip hazards may exist.

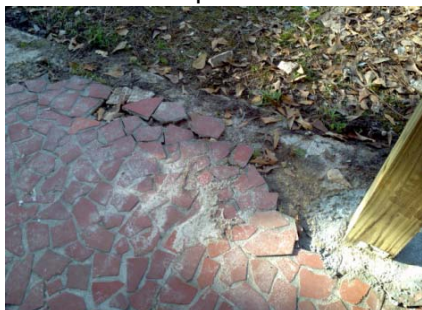
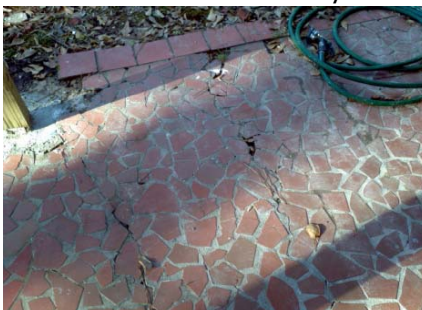
- #3** * The rear tile patio is cracked and deteriorated and will most likely need to be replaced with a concrete slab patio.

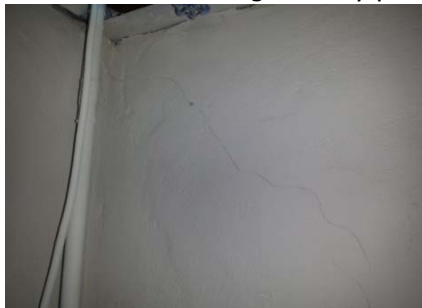
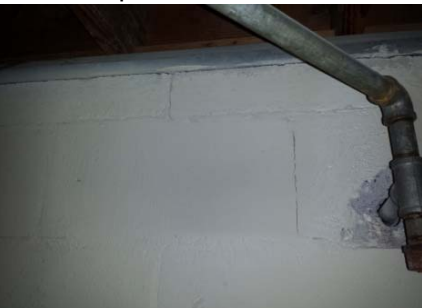
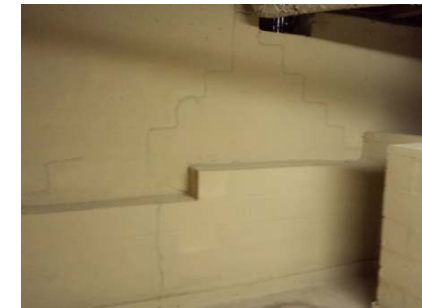
- #4** * There are several significant patches of the block foundation walls and there is a professionally installed water control system along the exterior walls the result of settling and moisture penetration into the basement of this home. Repairs were professionally done and a warranty should be included for the system and work. Recommend monitoring for additional cracking and any possible moisture penetration.

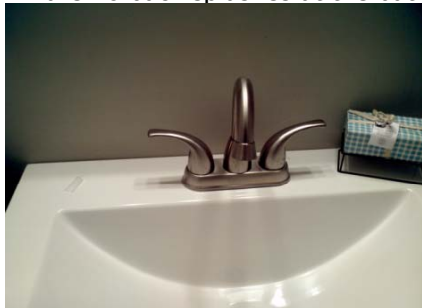
- #6** * Typically where a sink meets a wall a backsplash is provided to protect the wall from inevitable water damage. There are no back splashes at the bathroom sinks in this home.

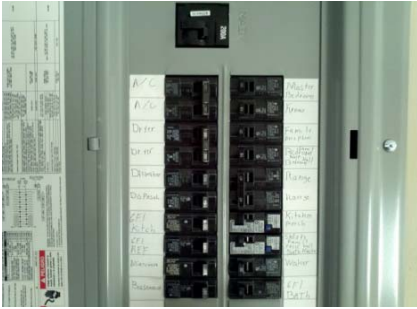
- #1** * While there have been two Arc-Fault Breakers installed in the main panel for what is labeled "kitchen porch" and "smoke family foyer hall bath master" current code requires this type of breaker on all outlet circuits in the home, this code upgrade is incomplete and does not comply with current code.

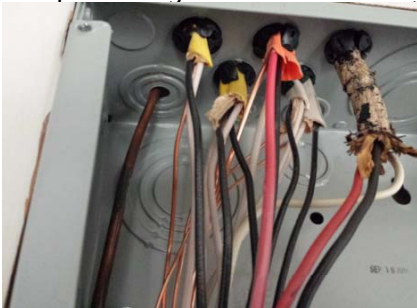
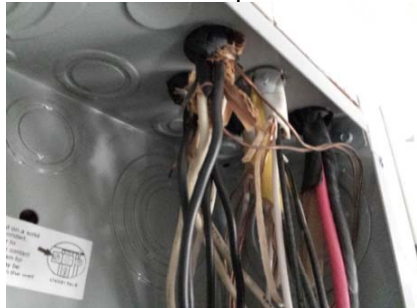
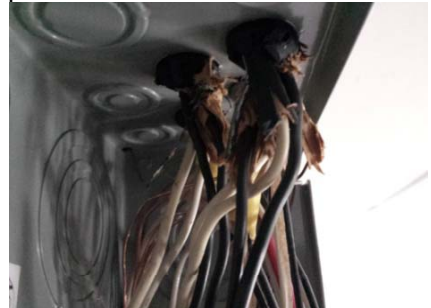
- #2** * Current code require all electrical outlets in the home to have safety grounds attached to a three prong outlet protected in the main panel with an Arc-Fault breaker. While most all of the electrical wiring have grounds attached in the main panel there are only ungrounded outlets in the main living spaces that had only cosmetic renovation. The one outlet opened had no ground wire in the box. Recommend evaluation by a qualified electrical contractor on options to ground outlets as ungrounded outlets will not protect attached equipment.

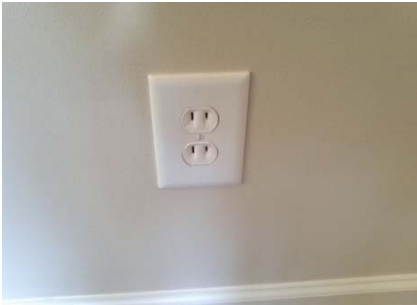
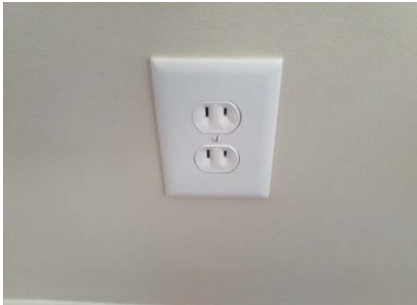
- #3** * While the copper water piping does appear to be grounded there needs to be visible jumpers between the cold and hot water piping and a jumper around the pressure regulating valve for safety and code. Additionally where the piping is outside the insulated living envelope or against exterior masonry walls the pipe should be insulated.
- #4** * As stated on page 6, the electrical outlets in the main level living spaces are ungrounded outlets that will require adapters to accept three prong plugs and will not protect electronic equipment from surges or lightning strikes.

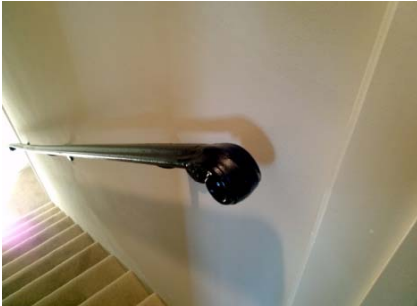
- #5** * Current code requires hand rails to return to the walls at either end to prevent anything from hooking on the rail. The handrail on the interior staircase is open ended.

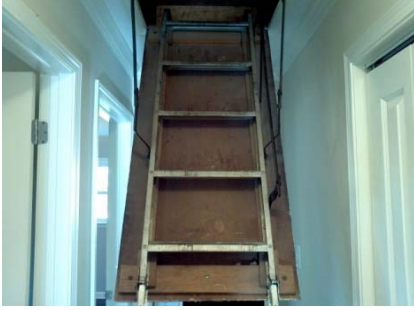
- #6 * The back board of the attic pulldown ladder should have some form of insulation installed, either a styrofoam insulating board or a fiberglass insulation mat. Weather stripping the edge of the back board is also recommended.

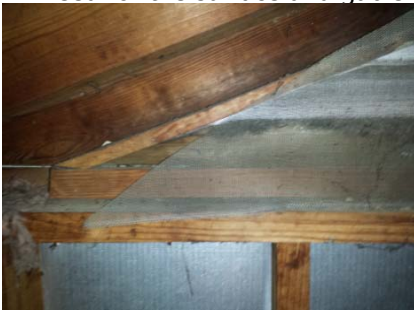
- #7 * The ventilation for this attic is insufficient for current construction practices and could cause roof shingles to curl and lift prematurely due to the build up of heat in the attic. A ridge vent would be the best option for this roof type. Recommend adding ridge and more soffit vents when the roof shingles are next replaced which would eliminate the need for the surface and gable vents. There is a loose screen on a gable vent that needs immediate repair.

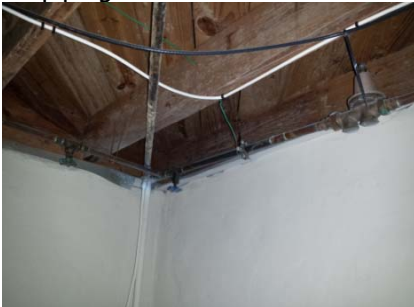
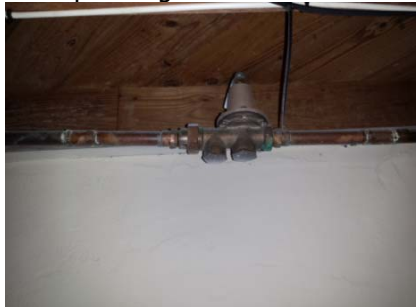
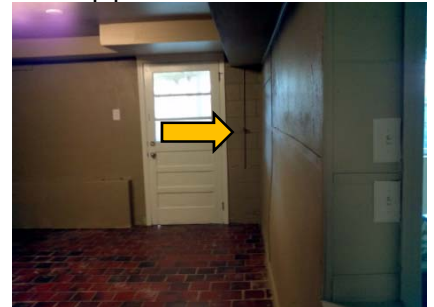
- #8 * While the copper water piping does appear to be grounded there needs to be visible jumpers between the cold and hot water piping and a jumper around the pressure regulating valve for safety and code. Additionally where the piping is outside the insulated living envelope or against exterior masonry walls the pipe should be insulated.
